3 WEST OF US 83 NORTH

IDENTIFICATION	
(1) State Names	North Dakota
(8) Structure Number	0094-156.609
(5) Inventory Route	00094
(2) Highway Agency District	61
(3) County Code	Morton, North Dakota

(4) Place Code	7200
(6) Features Intersected	MISSOURI RIVER
(7) Facility Carried	INTERSTATE 94
(9) Location	3 WEST OF US 83 NORTH
(11) Mile Point	156.576 mi

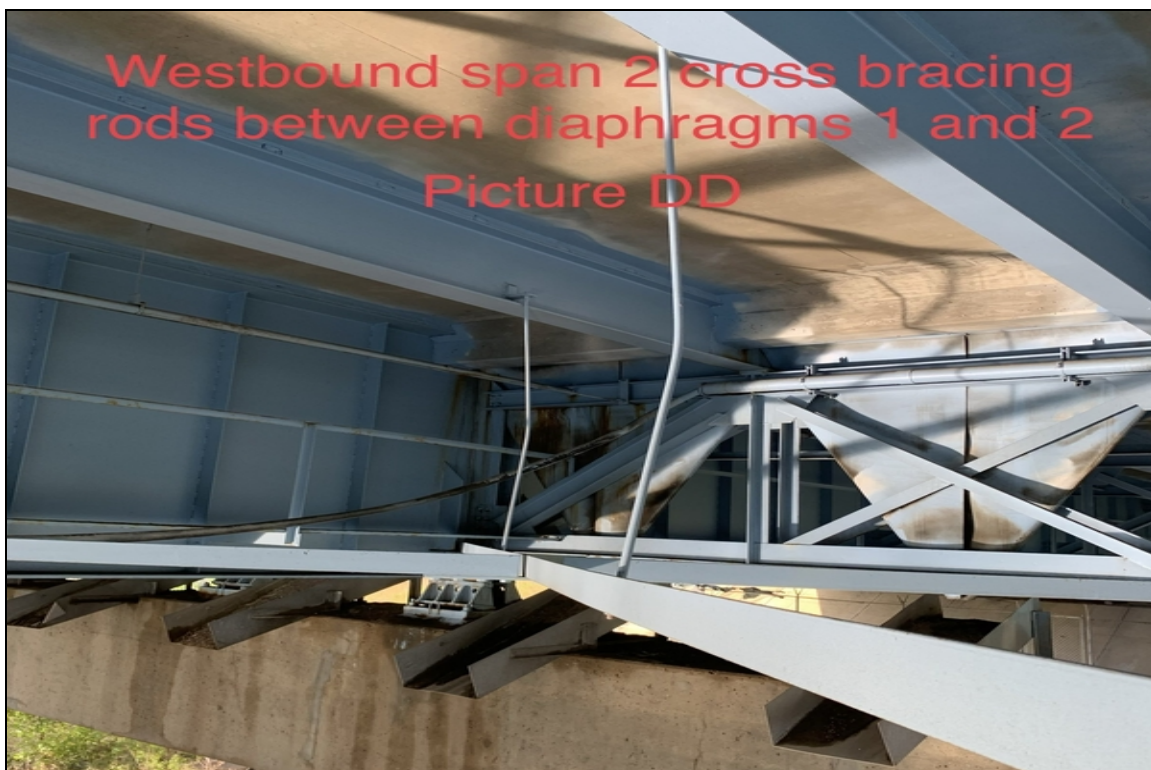
WB span 2 cross brace rods between diaphragm 1&2 (DD)

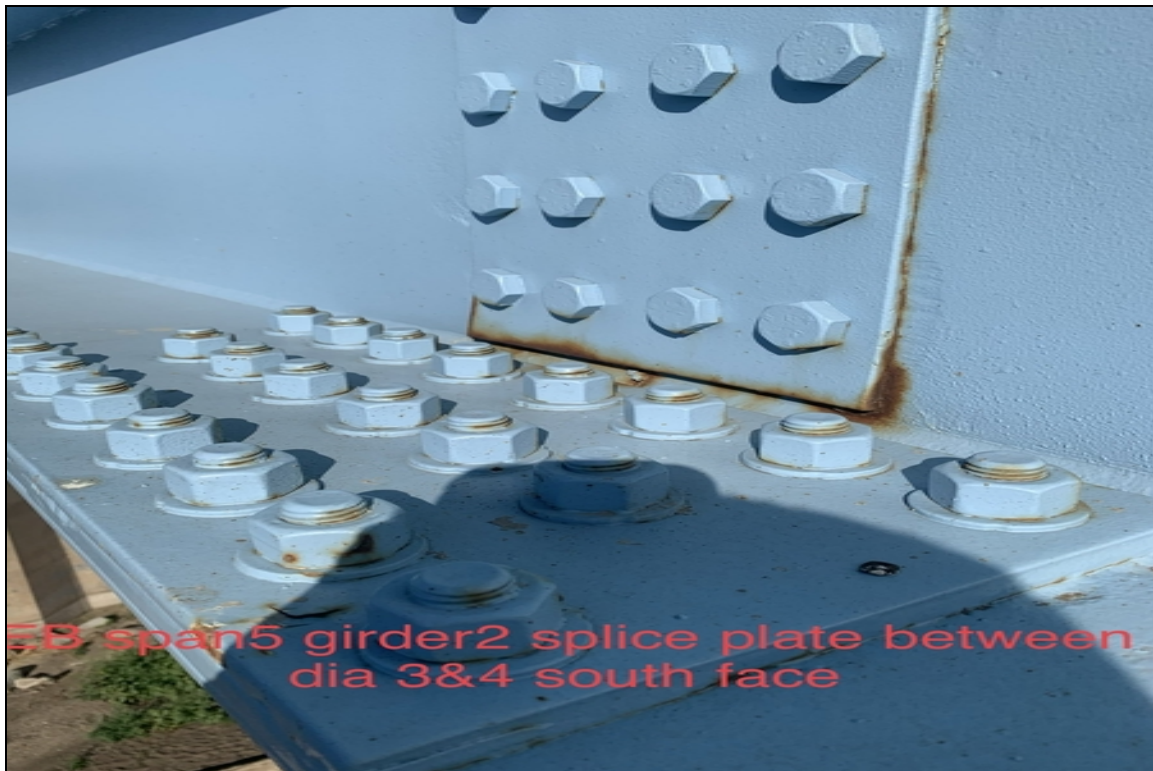
EB span 5 girder 2 splice plate between dia 3&4 south face

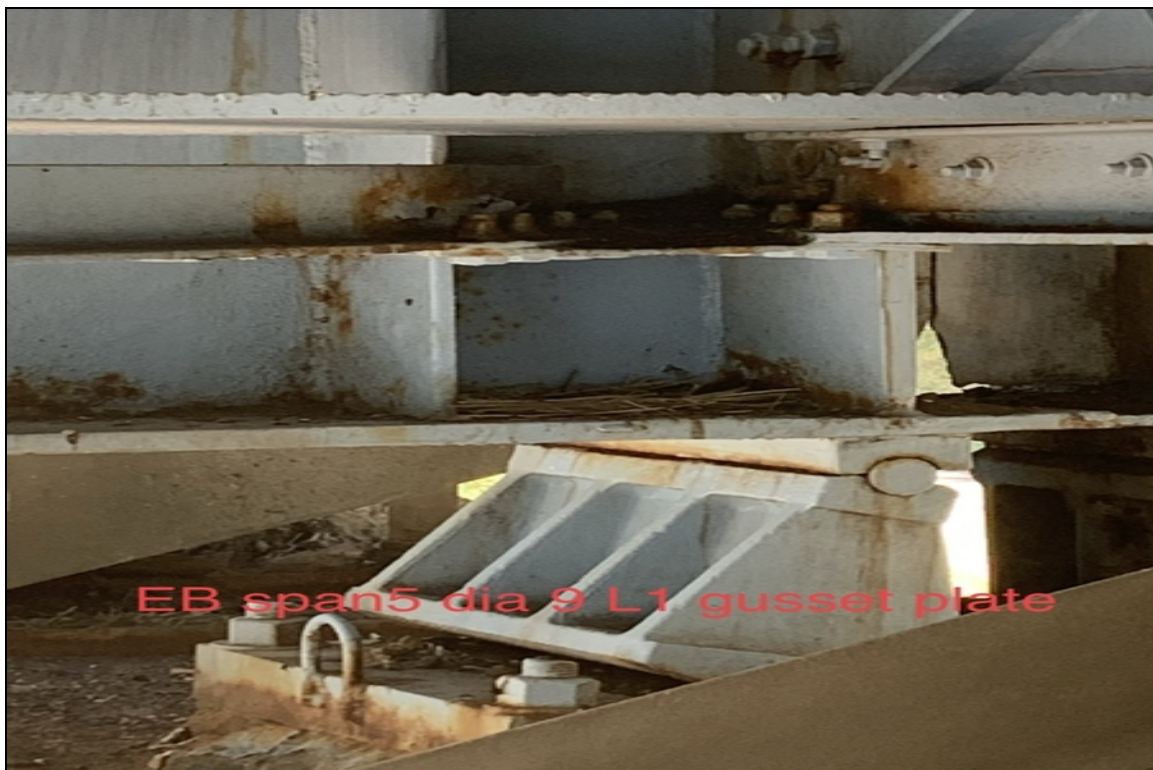
EB span5 dia 9 L1 gusset plate looking NE

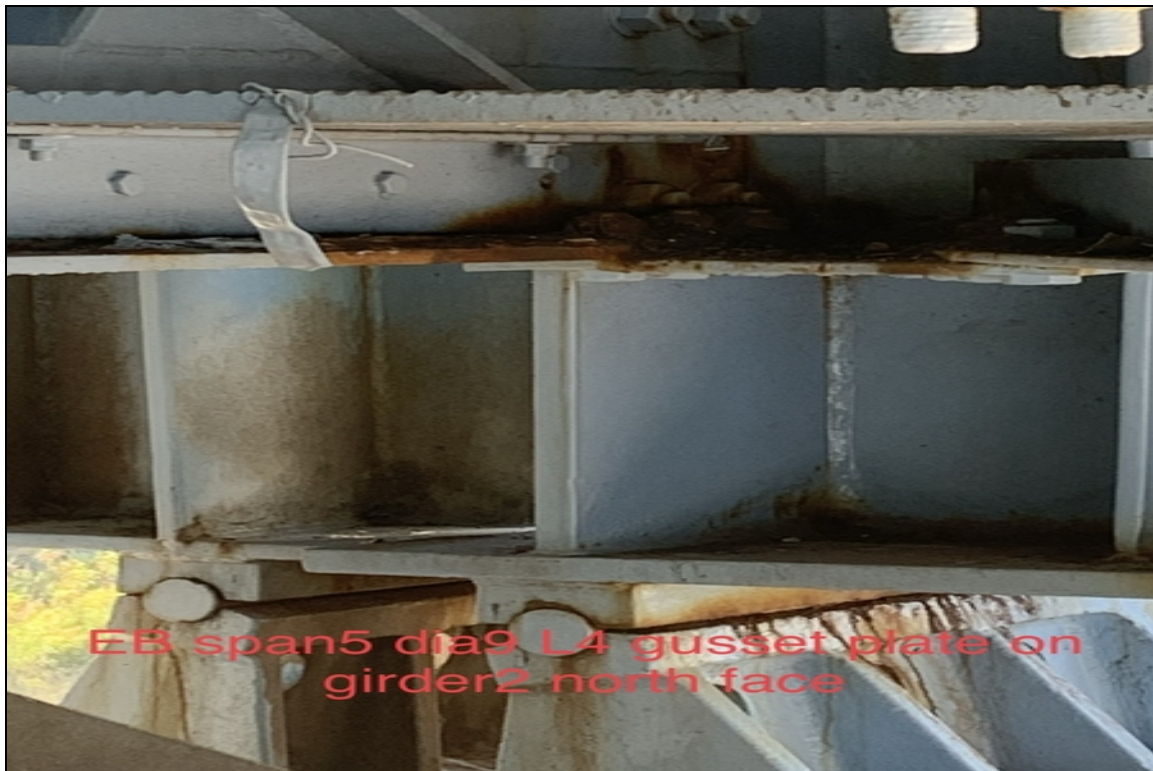
EB span 5 dia 9 L1 gusset plate girder 2 north face

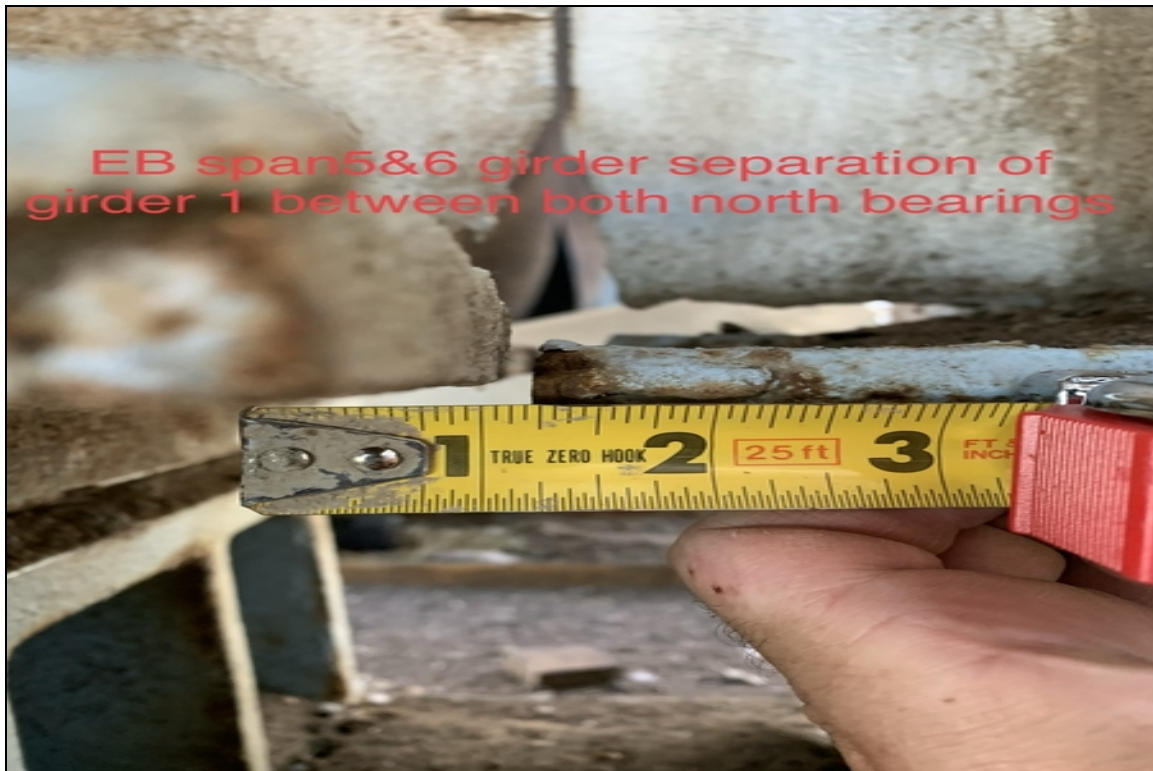
EB span 5 & 6 girder separation @ girder 1 Between both north bearings

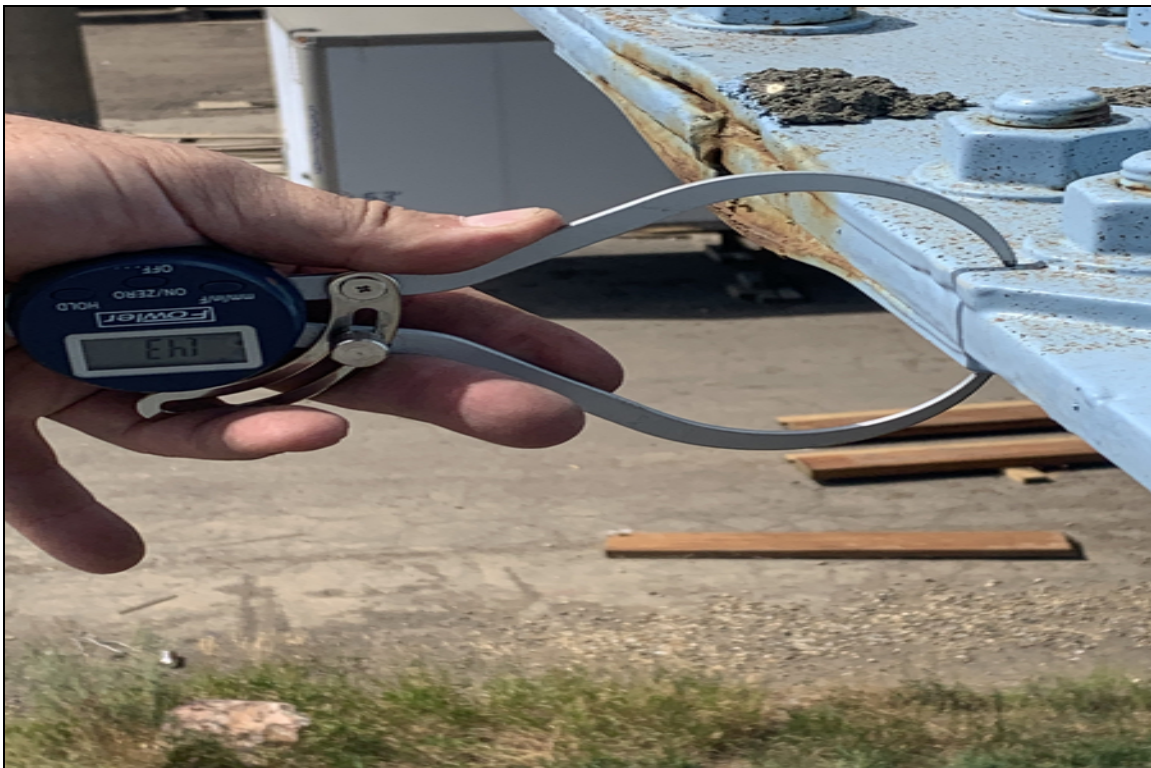
EB span 6 girder 2 splice plate original thickness 1.43"

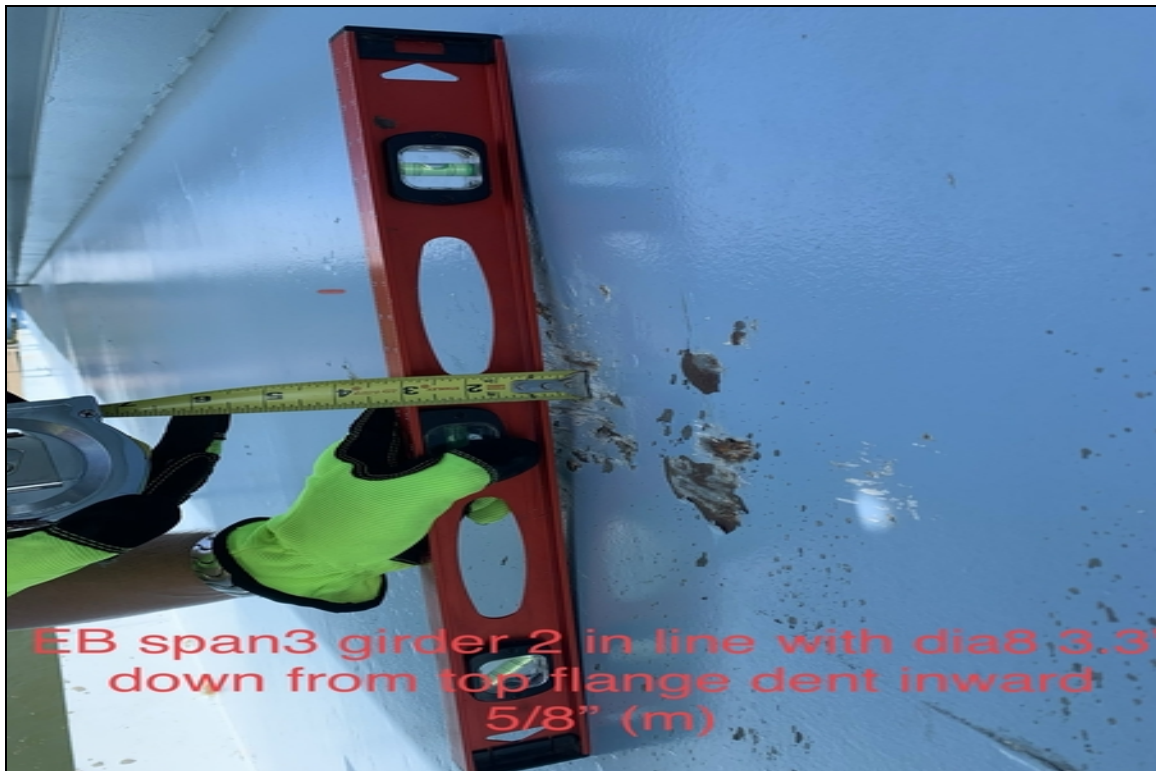
EB span 3 girder 2 inline with dia 8, 3.3ft down from top flange dent inward 5/8" (M)

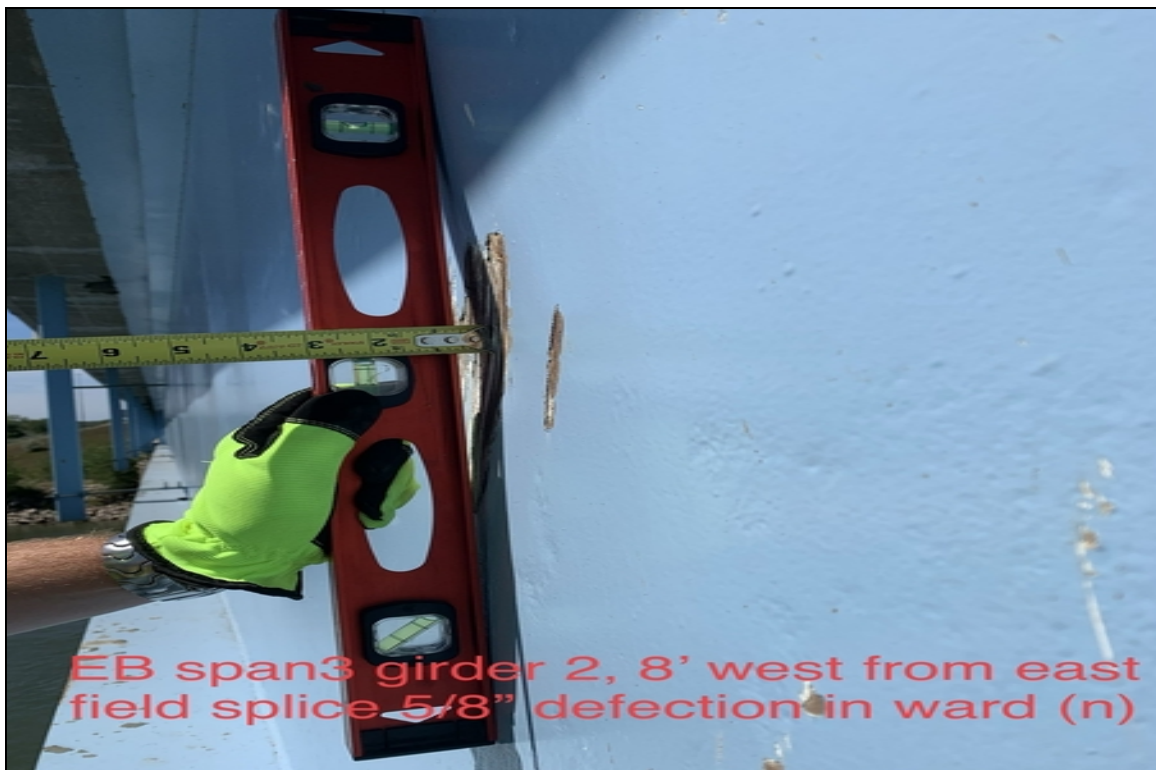
EB spa N3 girder 2, 8ft west from east field splice 5/8" deflection inward (N)

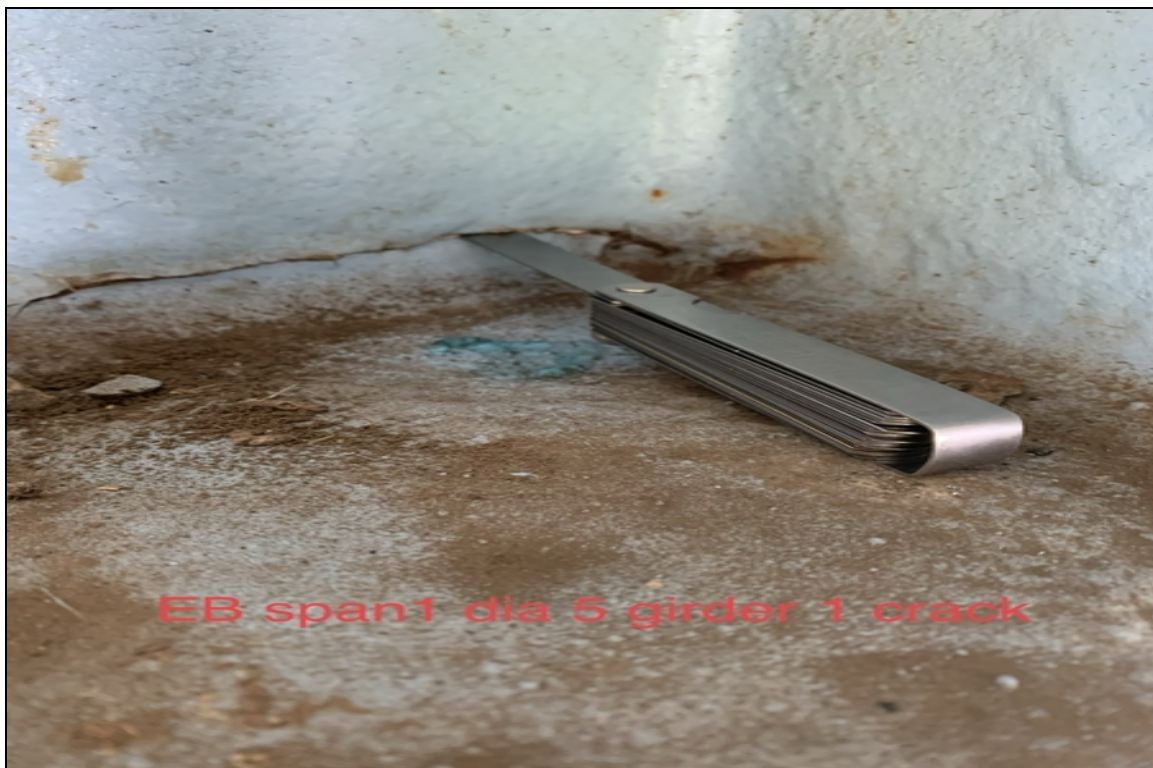
EB span 1 dia5 girder 1 crack in web above bottom flange (A)

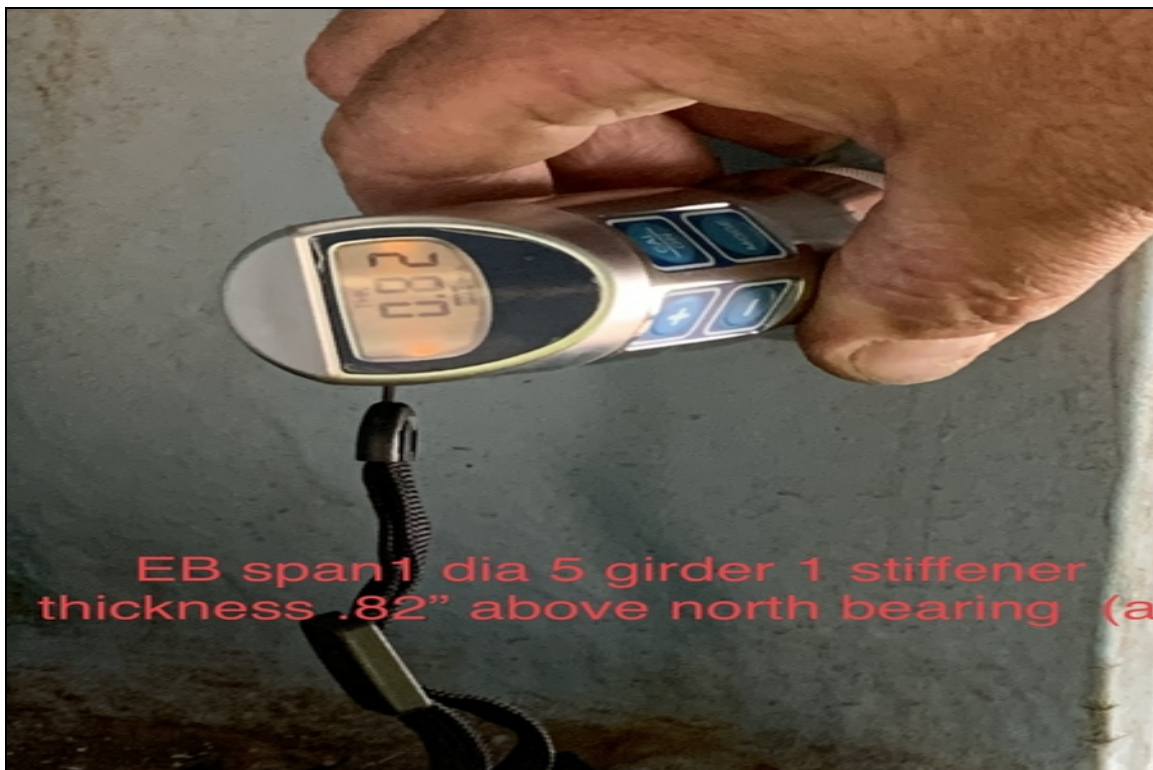
EB span 1 dia 5 girder 1 transverse stiffener thickness of .82" above north bear

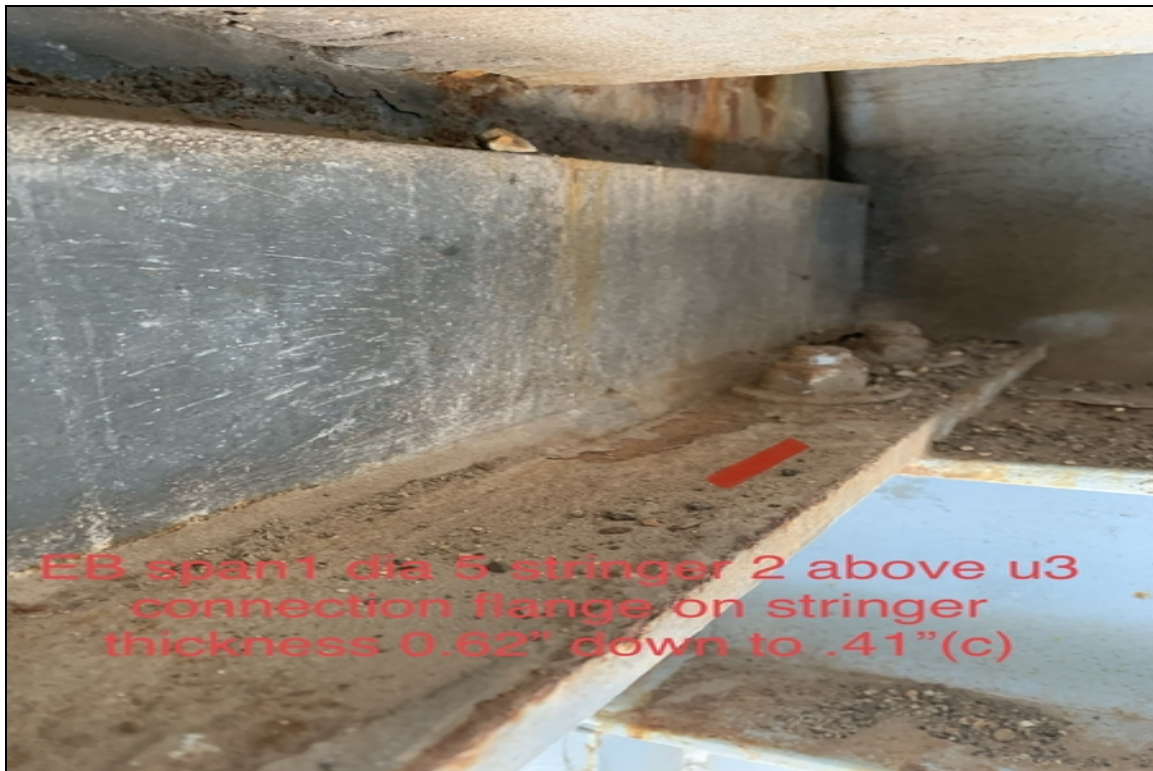
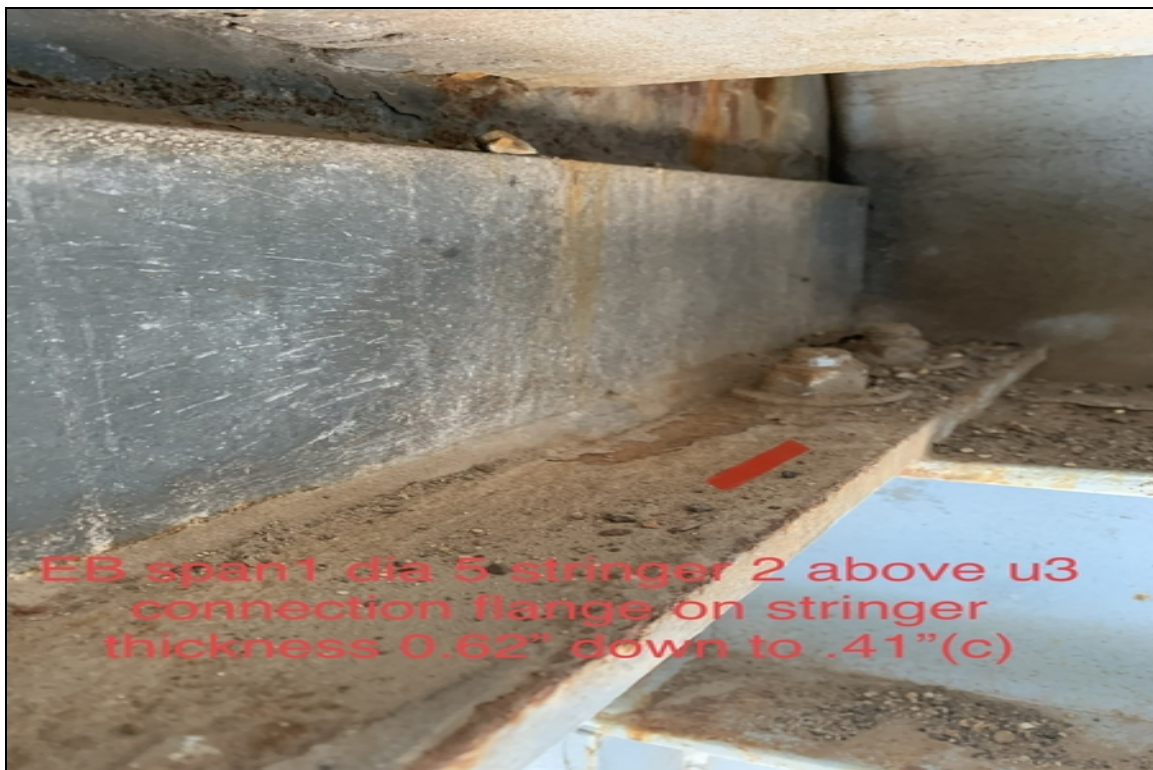
EB span 1 dia 5 stringer 2 above U3 connection flange on stringer thickness 0.62" down to 0.41" (C)

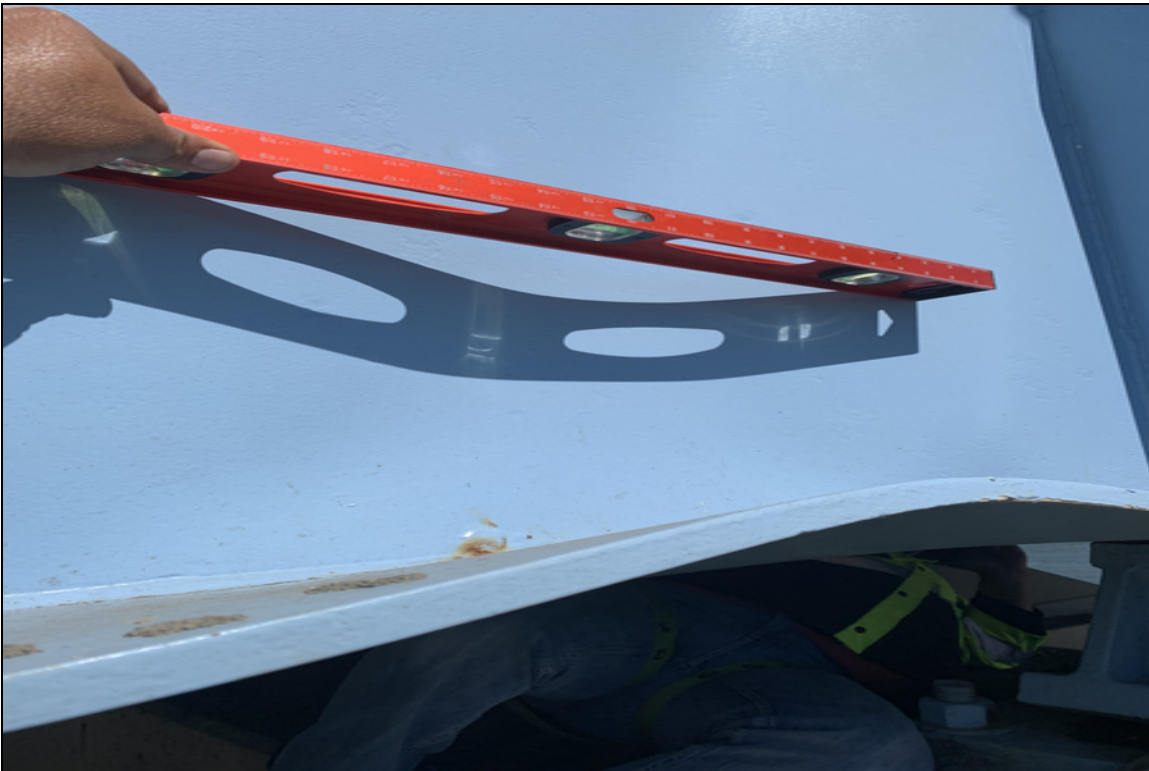
EB span 1 girder 2 approx 2ft west of dia 5 south rocker distortion inward (D)

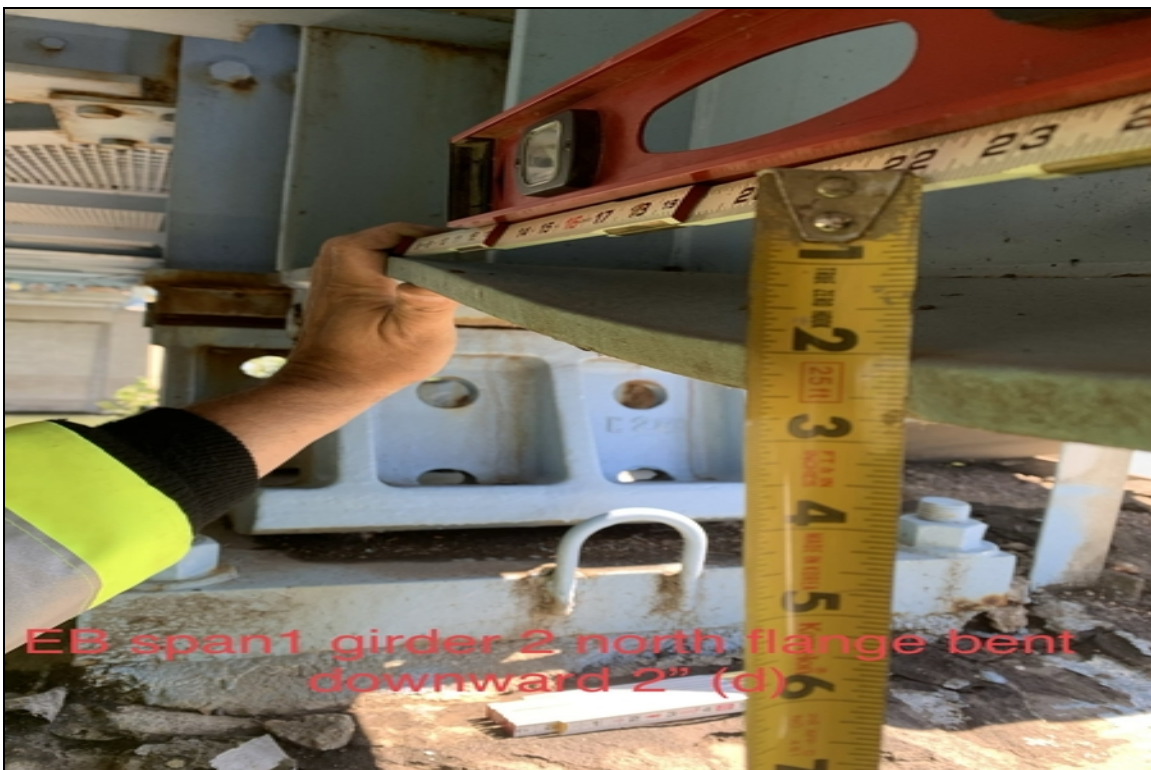
EB span 1 girder 2 north flange bent downward 2" (D)

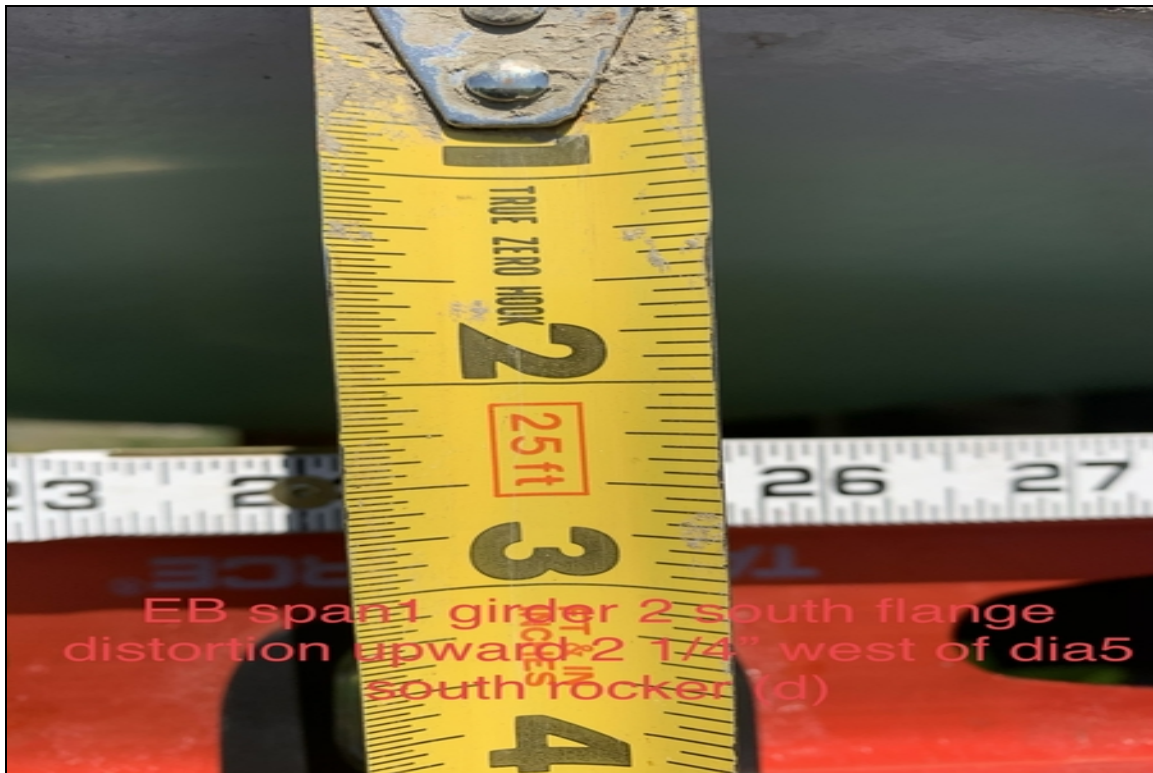
EB span 1 girder 2 south flange  
distortion upward 2 1/4" west of dia 5  
south rocker (d)

EB span 1 girder 2 south flange distortion upward 2 1/4" west of dia 5 south rocker (D)

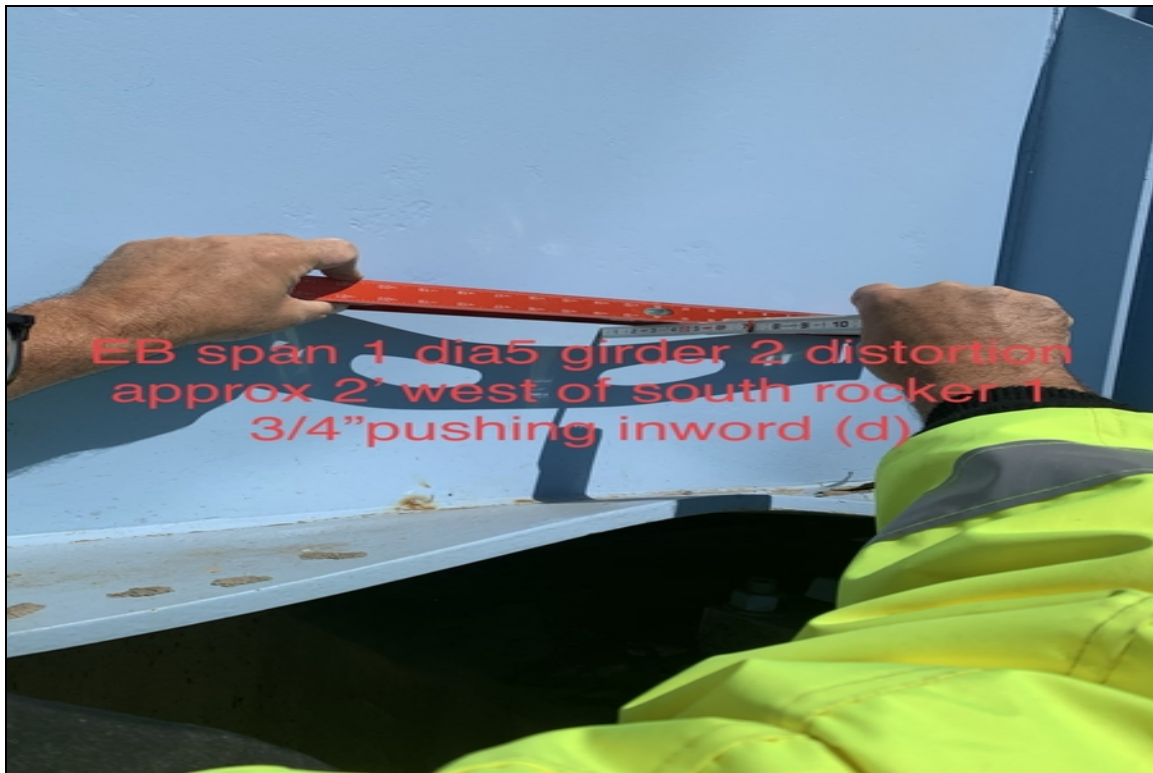
EB spa N1 dia 5 girder 2 distortion approx 2ft west of south rocker 1 3/4" pushing inward (D)

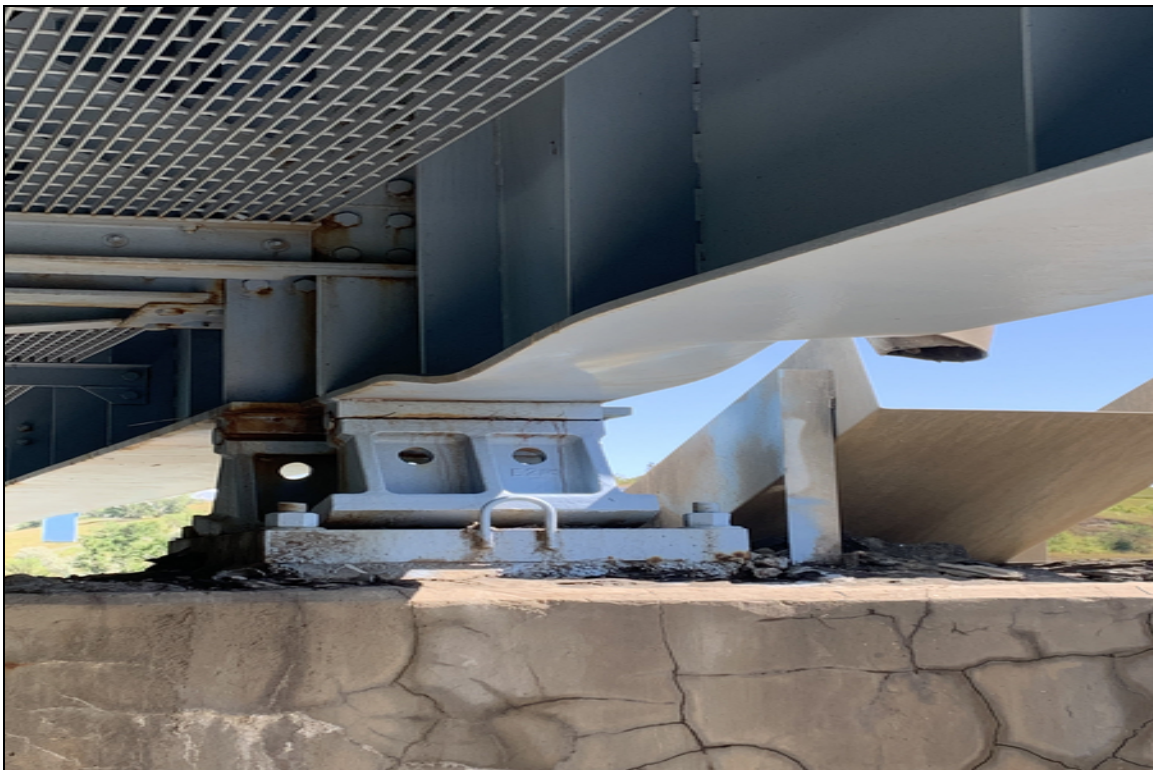
EB girder 2 span 1 dia 5 girder distortion

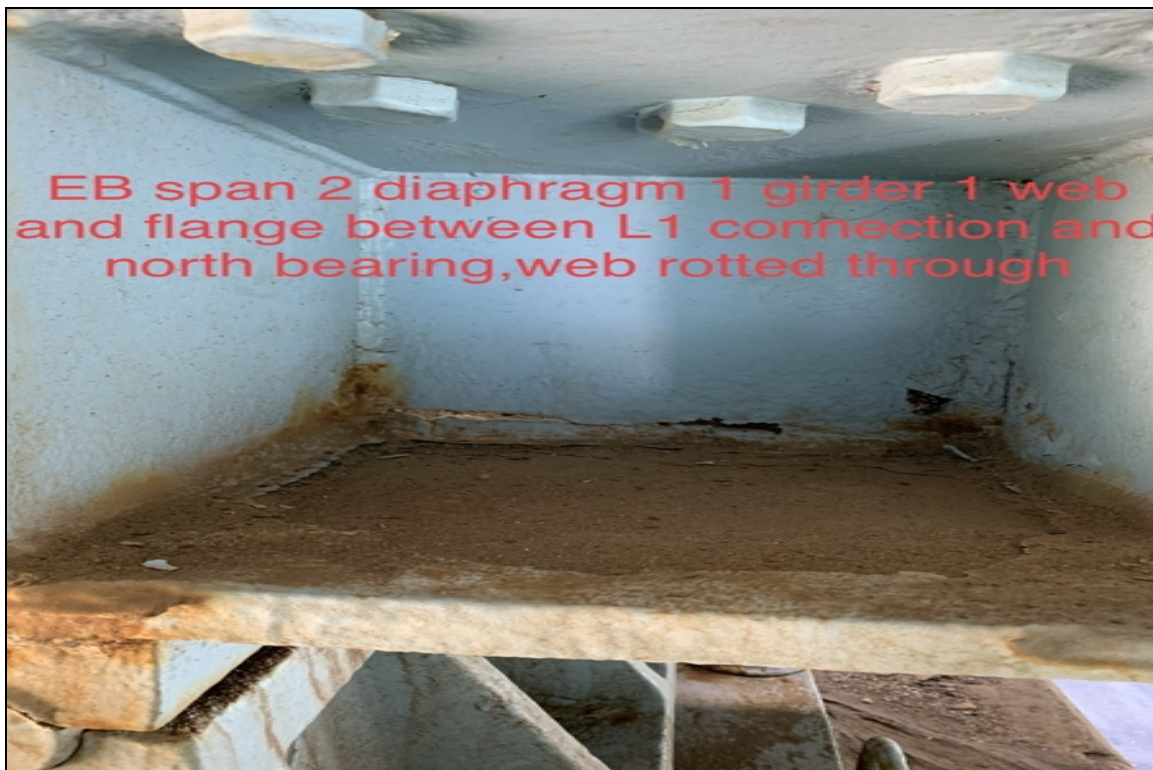
EB span2 dia 1 girder 1 web and flange L1 connection and above north bearing, web on girder rotted through

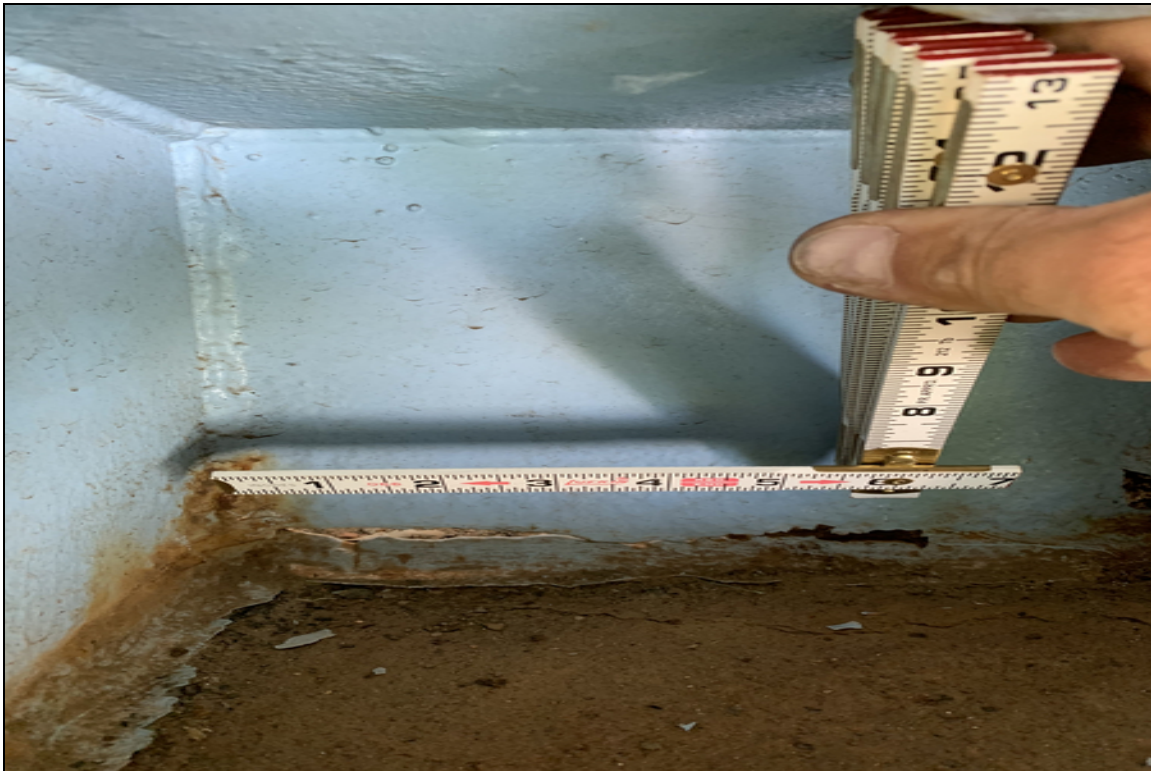
EB span 2 dia 1 girder 1 web and flange connection above north bearing 6" to rotted hole from transvers stiffener

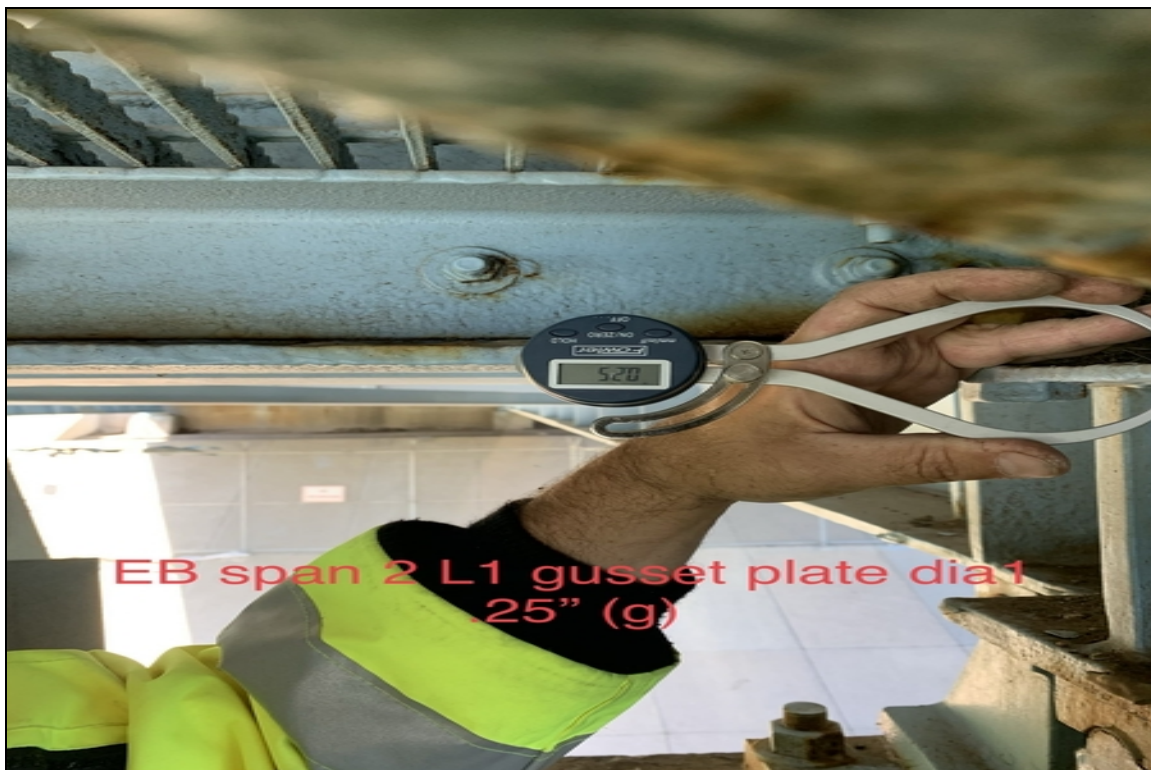
EB span 2 L1 gusset plate dia 1  
25" (g)

EB span 2 L1 gusset plate dia 1 0.25" thickness

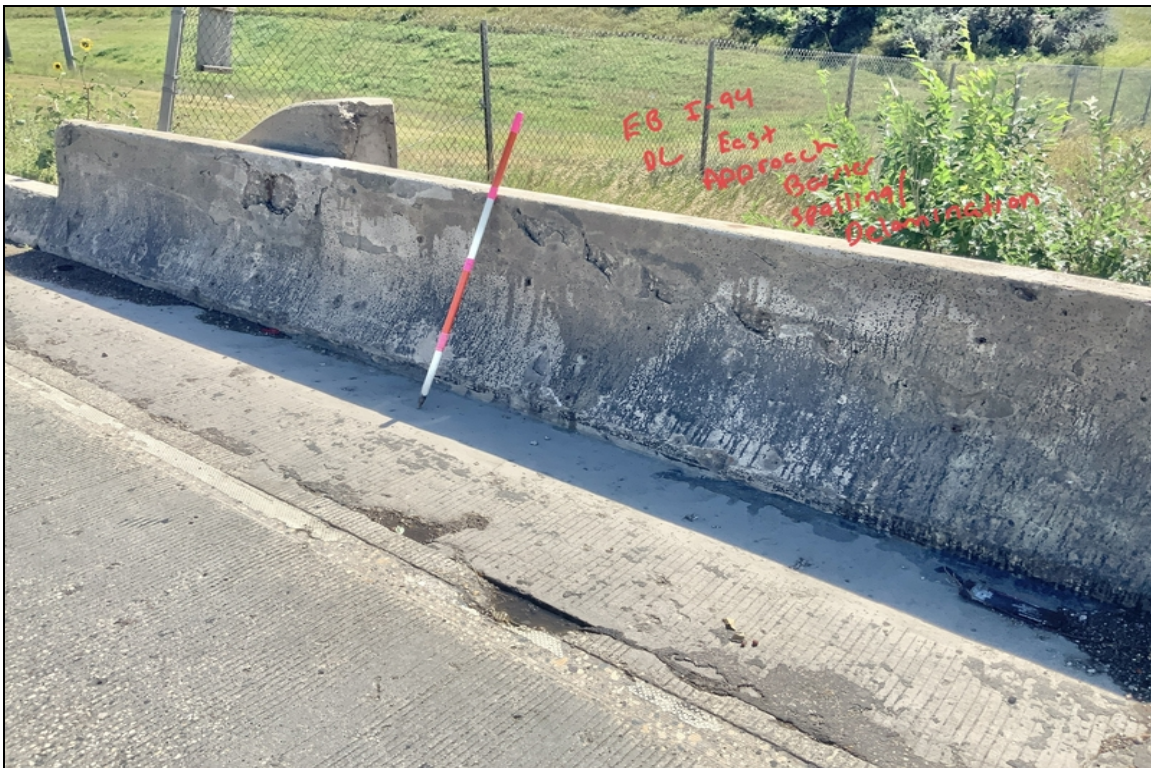
Facing SE. Delamination to SE Concrete Barrier to EB DL Approach.

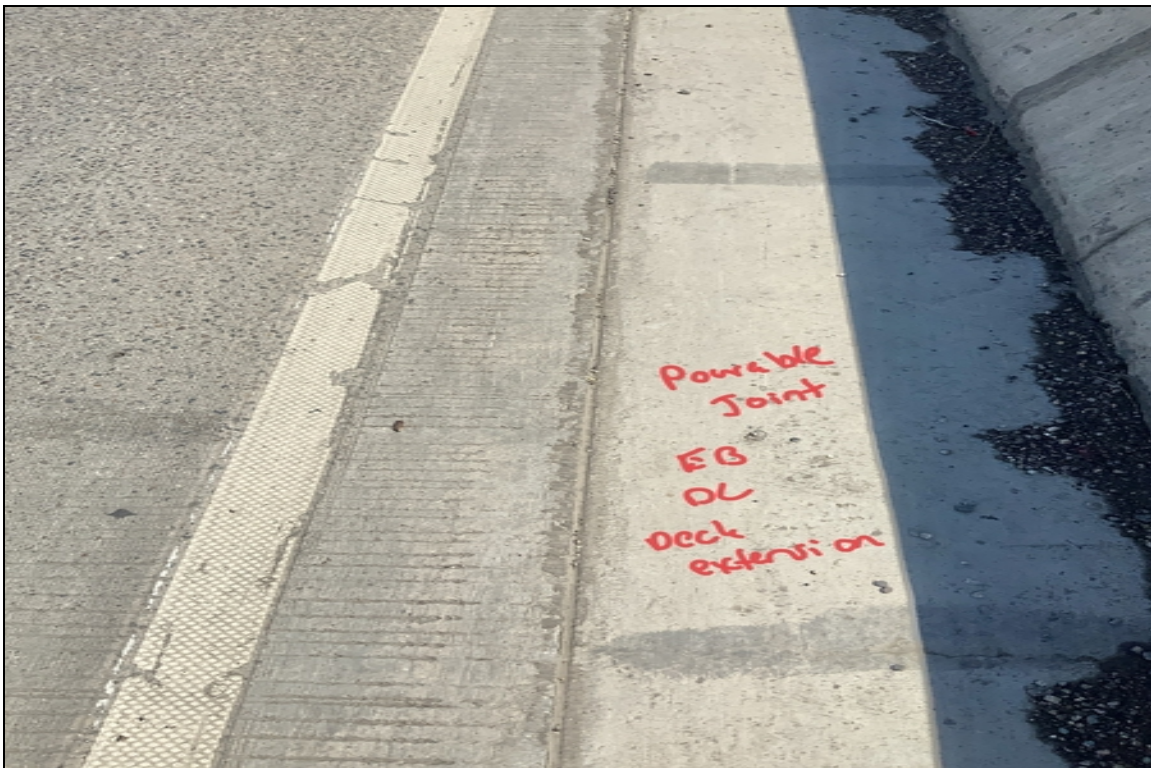
Facing East and Downward. General View of Porable Joint Seal to EB DL Deck Extension.

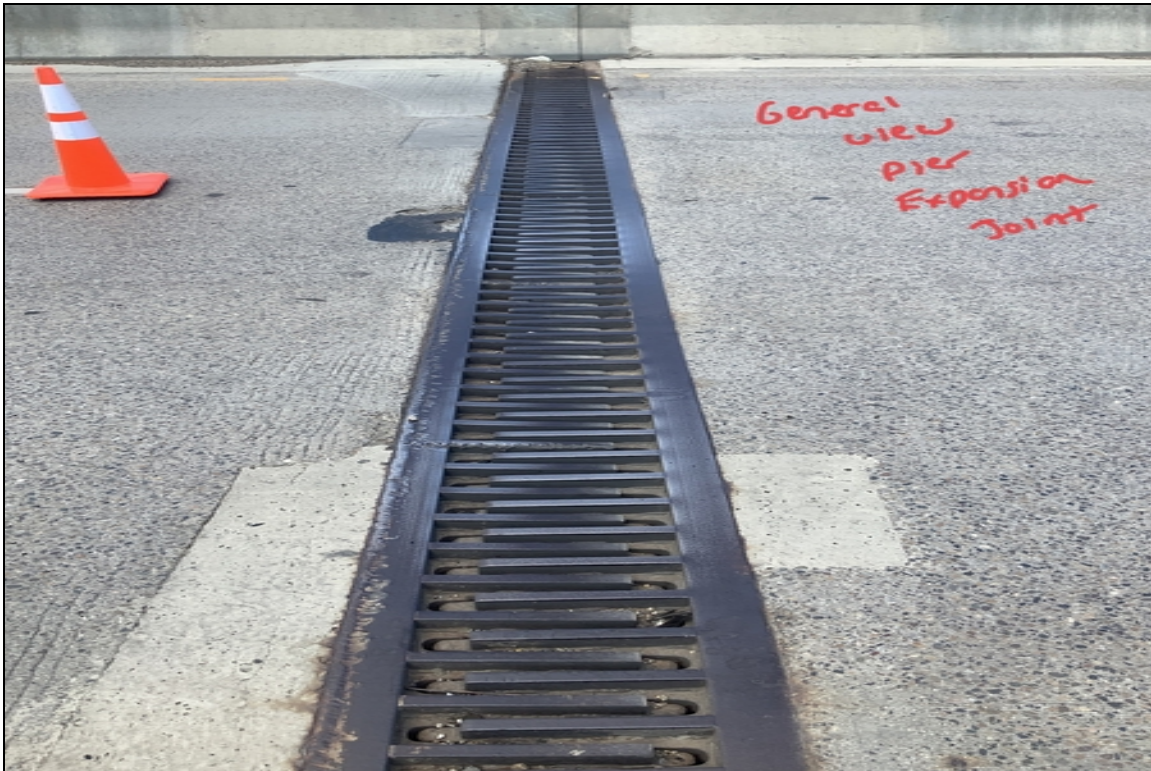
Facing North. General View of Pier 2 Expansion Joint.

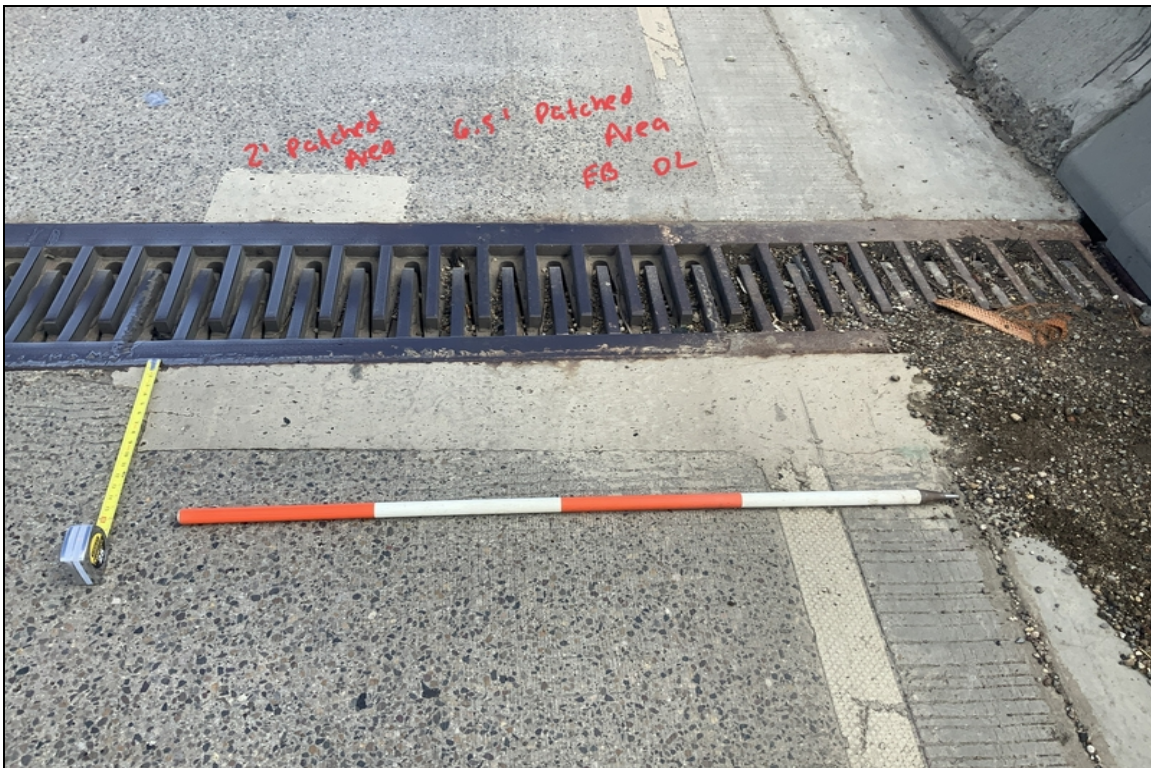
Facing East and downward. Header Patched areas along Pier 2 Expansion Joint EB DL.

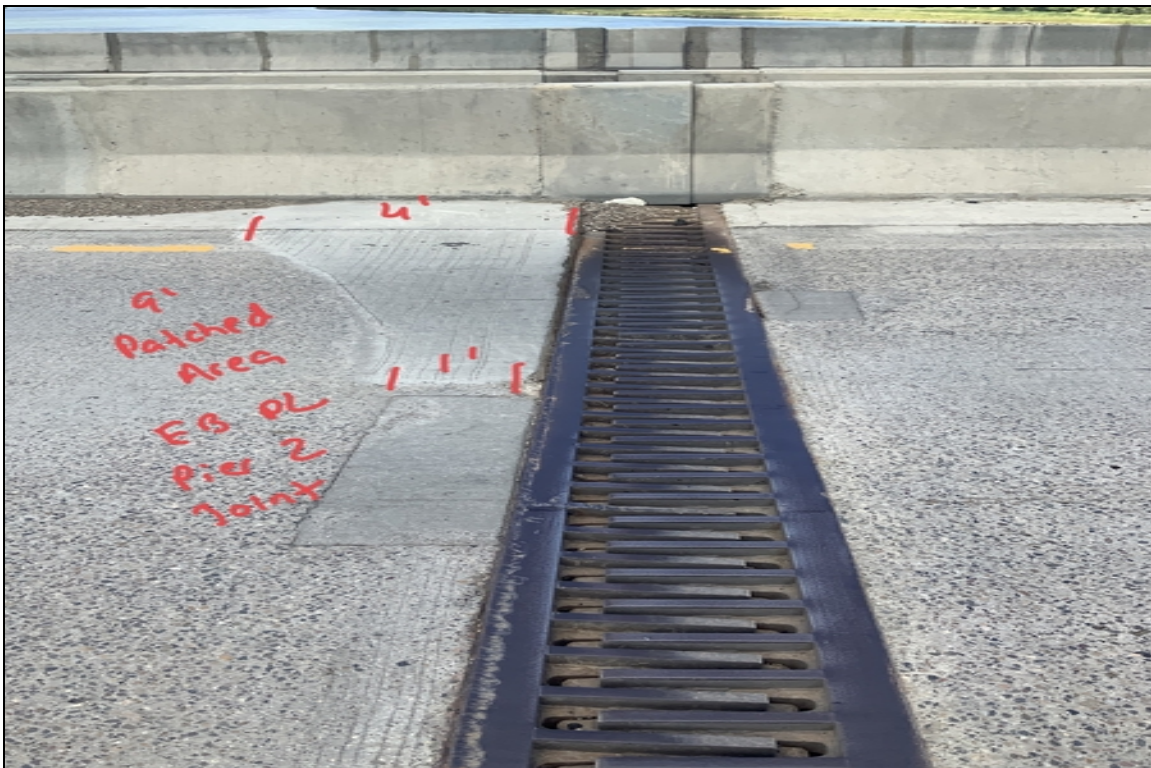
Facing North and Downward. Header Patched Area to EB PL at Pier 2 Expansion Joint.
